ARCHEOLOGICAL INVESTIGATIONS

FORT MOULTRIE
SULLIVAN'S ISLAND, SOUTH CAROLINA

(PRELIMINARY REPORT

SOUTHEAST ARCHEOLOGICAL CENTER

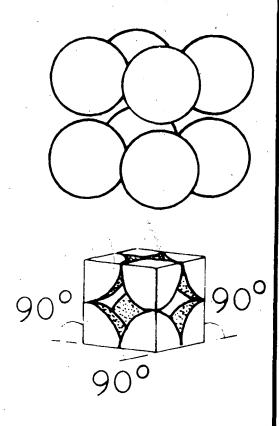
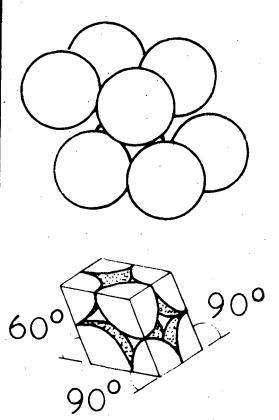
FIGURE 31. Subsurface Occurrence of Groundwater

Spherical Packing

Rhombohedral Packing

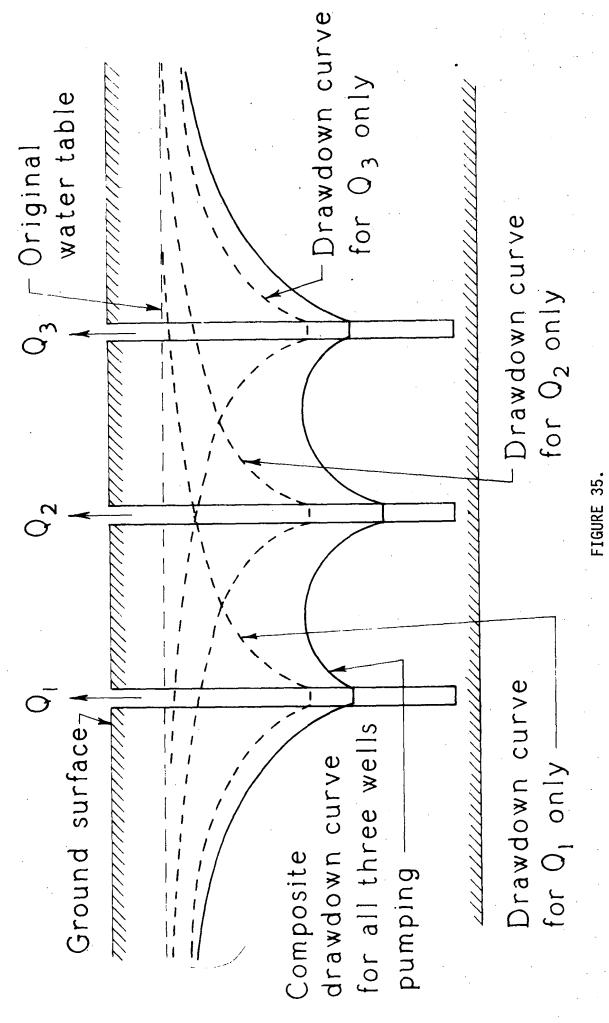
Individual and composite drawdown curves for three wells in a line.

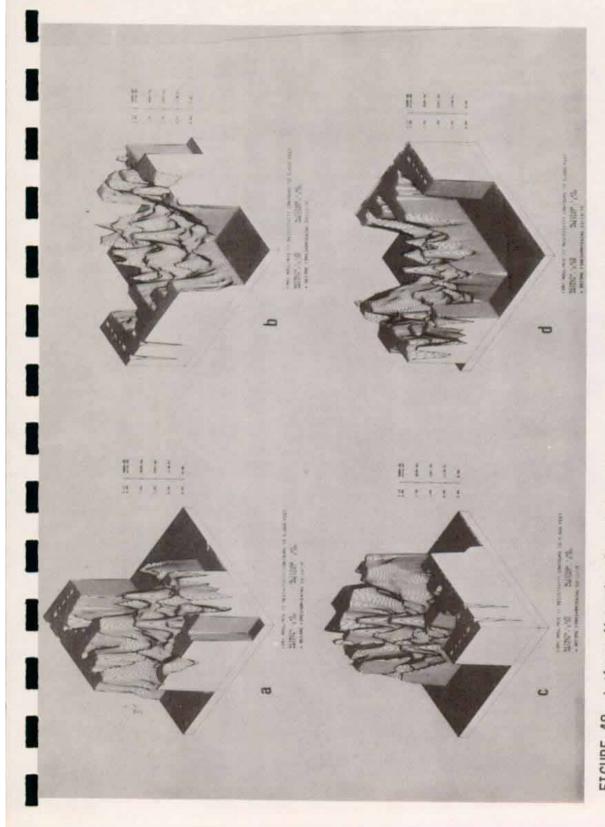
The upper left hand corner of map g is adjacent to the existing seaward wall of the fort. Map b is rotated 90° counter clockwise, map g is rotated 90° further, map d is 90° further. FIGURE 48. A three dimensional resistance contour map of the suspected area of Fort Moultrie II.

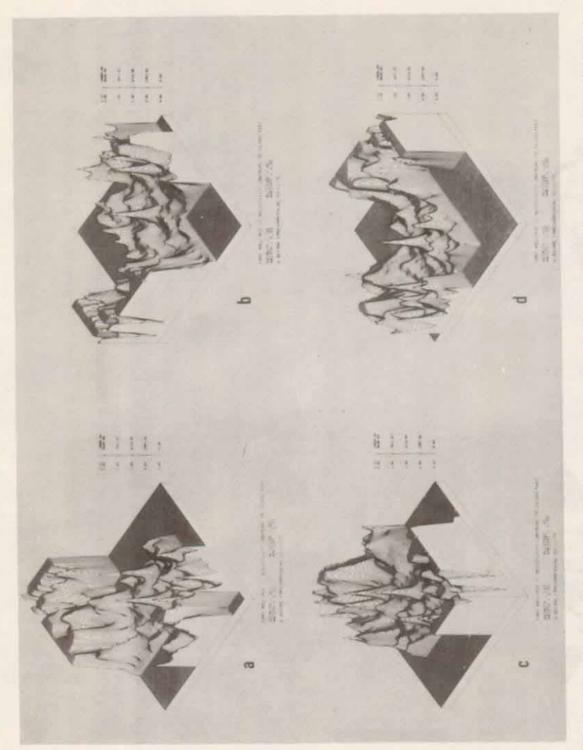
FIGURE 49. A three dimensional resistance contour map of the suspected area of Fort Moultrie II. The upper left hand corner of map g is adjacent to the existing seaward wall of the fort. Map b is rotated 90° counter clockwise, map g is rotated 90° further, map d is 90° further.

are four views of each representing a rotation of 90° . The flat grey low areas represent areas that were <u>not</u> measured during the survey, and the high greys are where the peaks were cut off at whatever top value was used according to the scale used for that particular figure. The upper left hand corner of map <u>a</u> in each figure is adjacent to the existing seaward wall of the existing Fort Moultrie. Map <u>b</u> is the same rotated 90° counterclockwise, map <u>c</u> is rotated 90° further, etc. The different vertical scales were experimented with, enabling the three different impressions of the resistance values to be plotted.

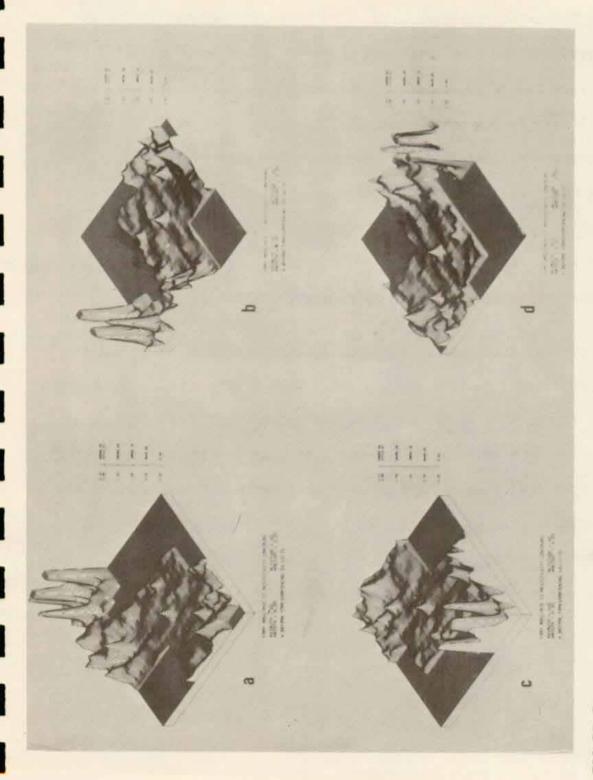
FIGURE 50. A three dimensional resistance contour map of the suspected area of Fort Moultrie II. The upper left hand corner of map g is adjacent to the existing seaward wall of the fort. Map b is rotated 90° counter clockwise, map g is rotated 90° further.
